Investigation of surface damage caused by multiple laser-induced single bubble cavitation

Jonas Kühlmann¹, Christina Lopez de Arcaute y Lozano ²,
Stefanie Hanke², Sebastian A. Kaiser¹

Experimental set-up: Bubble generation and detection

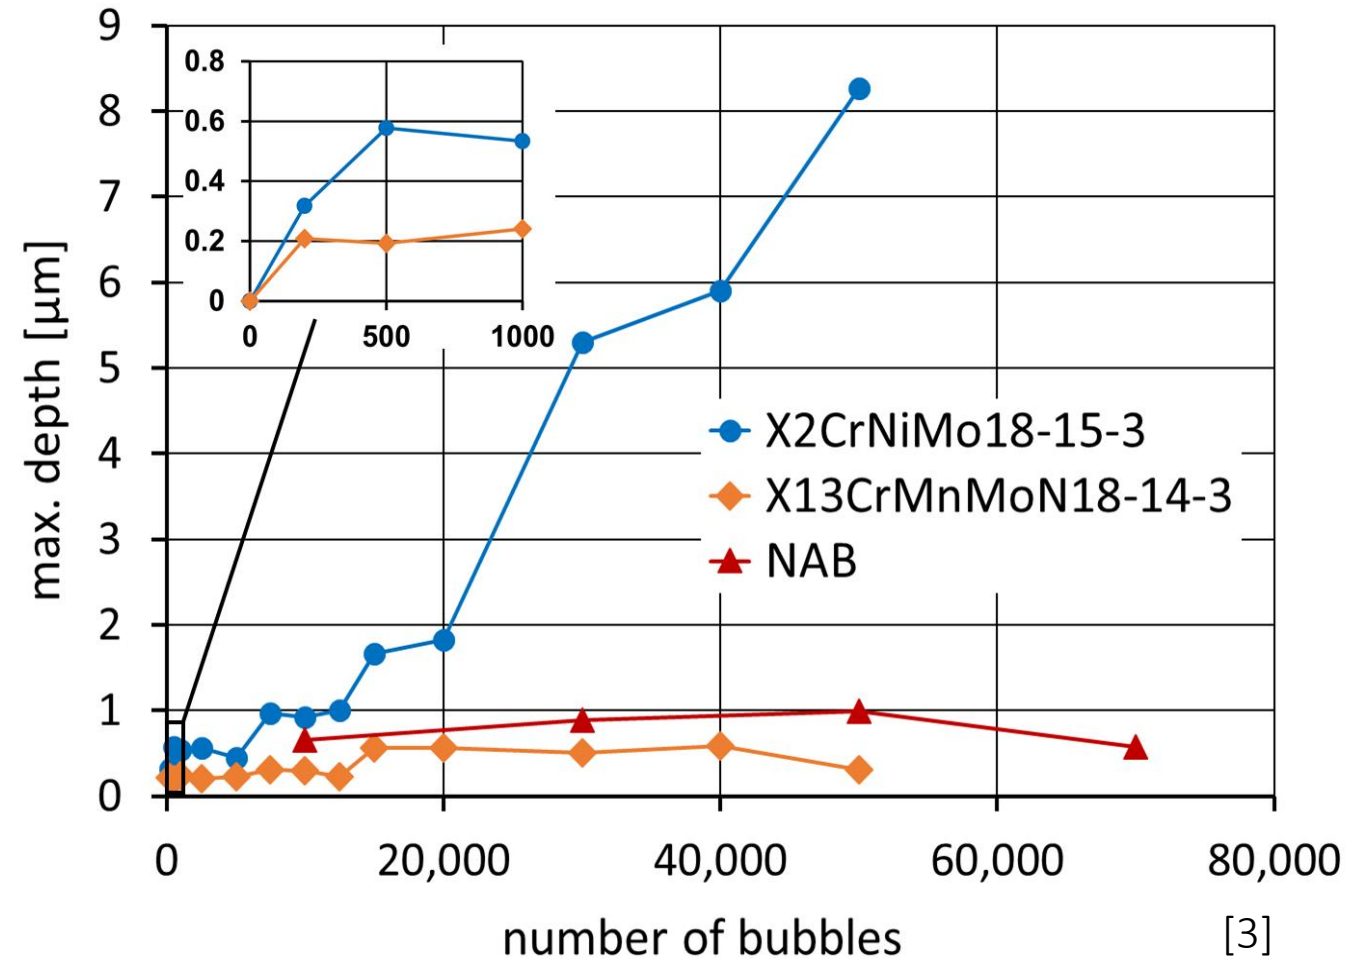
Ex-situ analysis of multi-bubble damage

- Maximum depth of the damage region is measured
- Ex-situ damage analysis
→ new sample for each data point
- Fluctuations are not physical
→ in-situ operando imaging of damage evolution
